Heavy Anti-corrosion

VRV MAX

COOLING ONLY 50/60Hz

R-410A

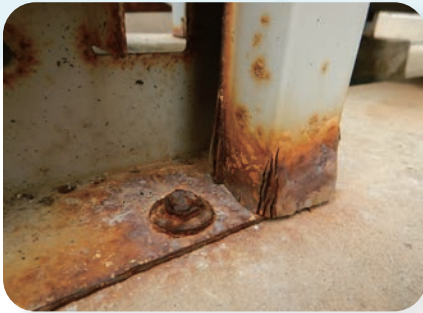
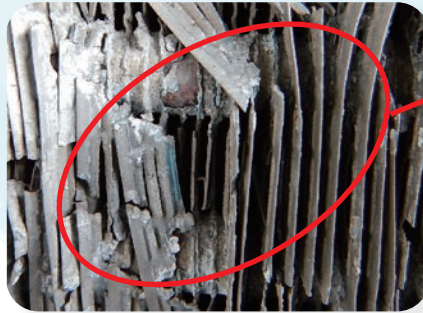
Outer casing

Shortened Lifespan

Heat exchanger (Fin)

Inadequate Cooling Performance

Poor Efficiency

Corrosion often becomes a problem for air conditioners near the ocean. Corrosion damage reduces their efficiency and cooling capacity over time, and eventually leads to high replacement costs.

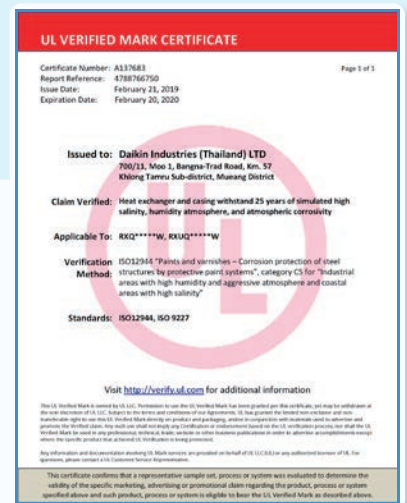
Heat exchanger and casing withstand 25 years* of simulated high salinity, humidity atmosphere, and atmospheric corrosivity.

Certified C5 high level in durability range of corrosivity category as defined in ISO12944-6:2018.

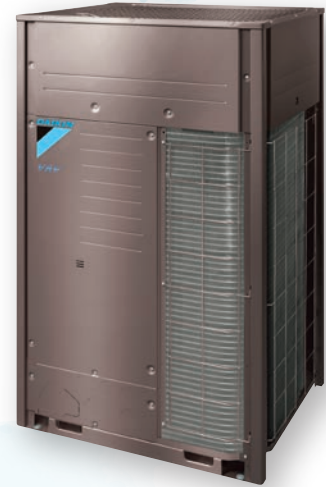
VRV MAX utilises hot-dip Zinc-Aluminum-Magnesium alloy coated steel sheet for superior corrosion resistance, with additional four-layer coating for even greater durability.

Standard model

VRV MAX

4-layer coating
